## UNITED TECHNOLOGIES RESEARCH CENTER

NASA CR-159747

Study of The Effects of Gaseous  
Environments on The Hot  
Corrosion Of Superalloy Materials

FINAL REPORT

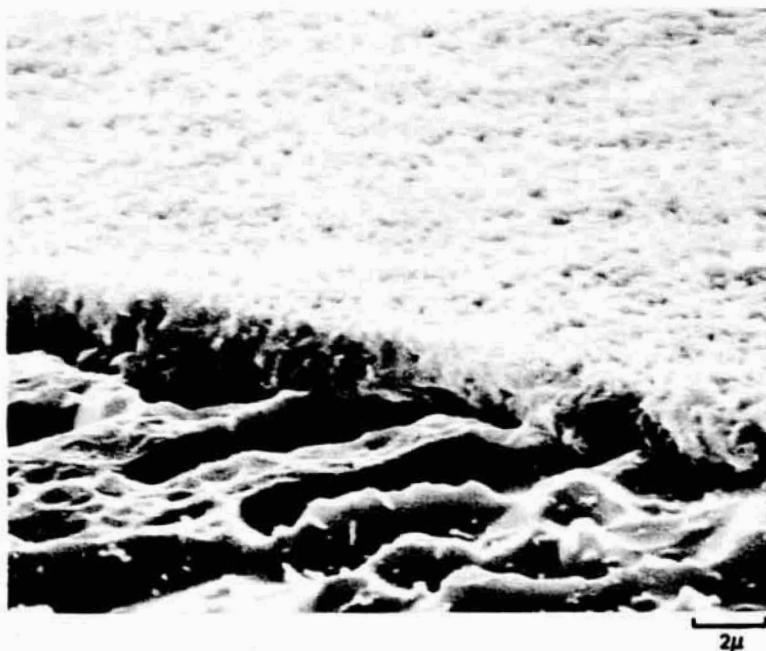
FIG. 1 NiAl oxidized in air alone at 1050°C for 100 hours.

Examination of the spalled and retained scales by scanning electron microscopy and EDAX techniques reveals the presence of multilayers of essentially pure alumina, Fig. 10. It also is apparent that the external alumina layer is poorly attached to the underlying protection alumina scale, Fig. 10, and both scales are highly faceted. Moreover, such exaggerated faceting of alumina crystals even exists at the scale-substrate interface, Fig. 10. On the other hand, scales produced by exposure to air alone do not exhibit such highly faceted crystals at this interface, cf. Fig. 1.

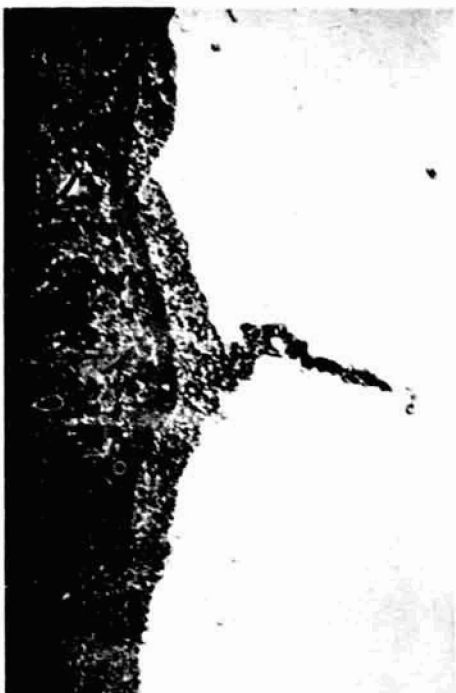
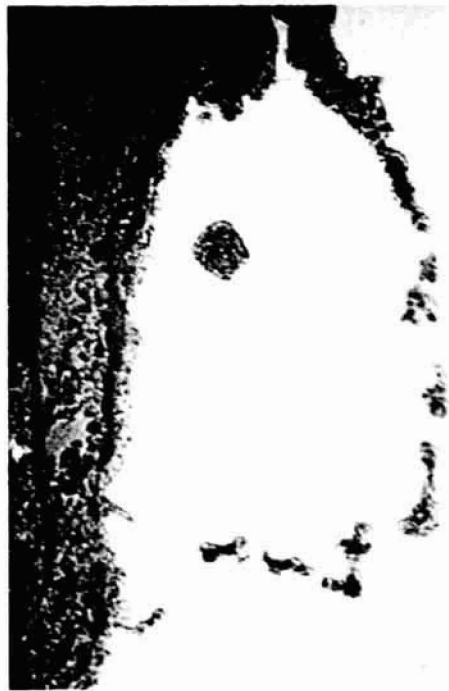
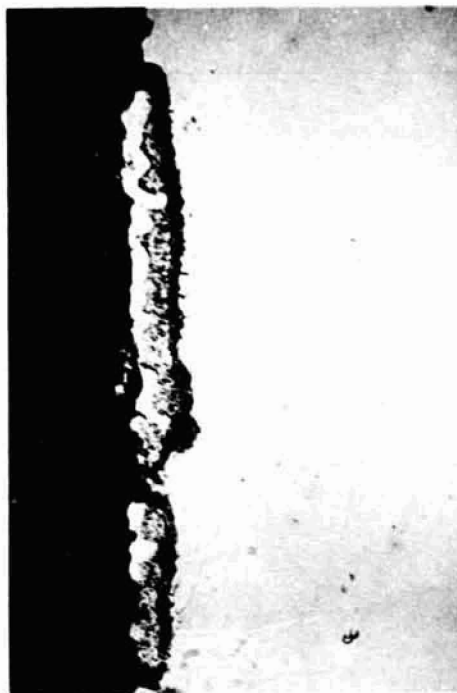
A. Dense oxide scale.

B. Grain boundary attack.

C. Oxidation loop.

D. Internal oxidation.

FIG. 5. Oxidation of Ni-25Cr at 1050 °C in air alone (100 hours).

The oxidation behavior of the various Ni-Cr alloys listed in Table I were also well behaved in that the scales formed were as described by numerous investigators (e.g., Refs. 19,20,21). The oxidation kinetics for these alloys were analogous to that for the Ni-25Cr composition, Fig. 3. In general, a chromia scale was observed on the surfaces of the alloys with a wide variation in oxide grain sizes and shapes. At 1050°C the surfaces exhibited a rumpled appearance with numerous mounds protruding from the surface, Fig. 4. Metallographic examination revealed the typical scale morphologies associated with these chromia formers as shown in Fig. 5.

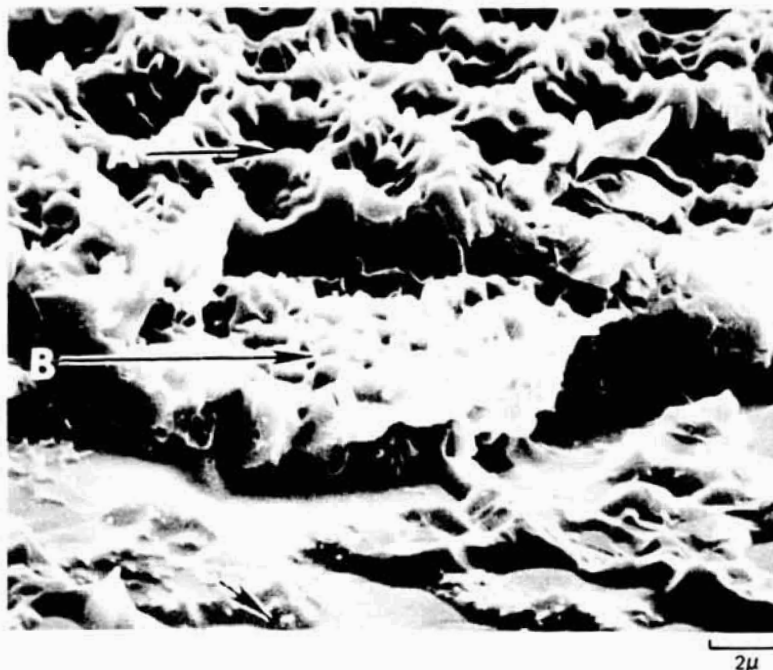
- A. Outer oxide scale
- B. Inner oxide scale
- C. NiAl substrate

Note cracks (A) between external (B) and internal scales (C)

FIG. 10 Microscopy studies--NiAl exposed at 1050°C to air with 10ppm NaCl(g) for 100 hours.

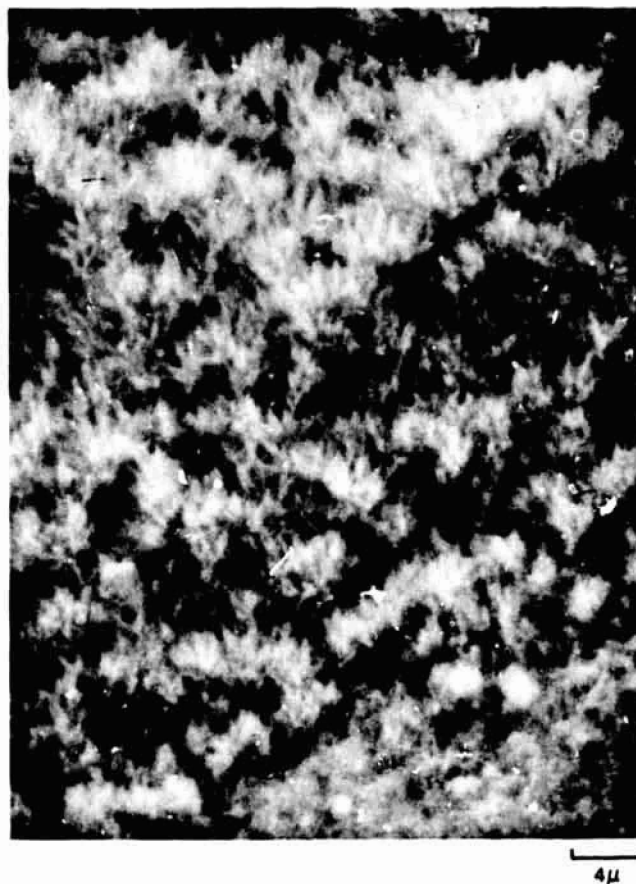
FIG. 13 Al<sub>2</sub>O<sub>3</sub> whiskers on CoCrAlY oxidized at 1050°C for 24 hours in air with 100ppm NaCl.

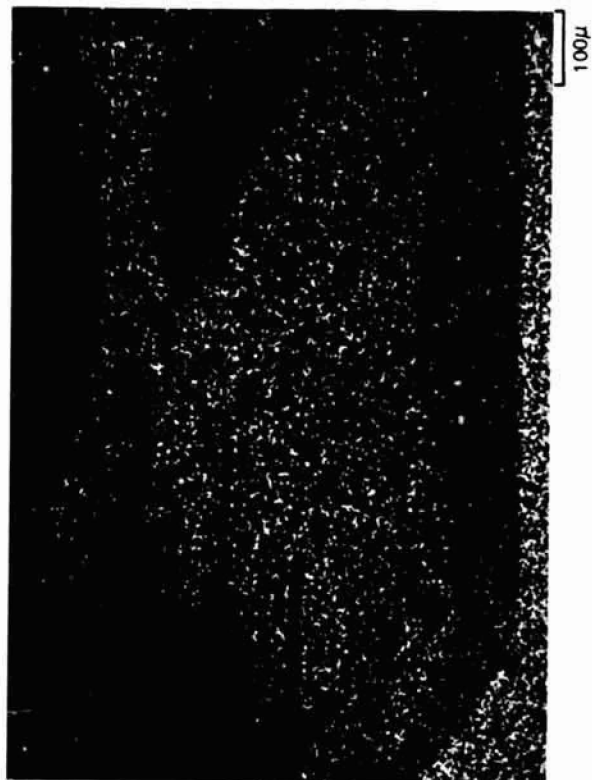
FIG. 20 B-1900 oxidized in air with 11ppm NaCl(g) for 100 hours.

The oxide scales formed on the surfaces of the nickel base superalloy were examined by scanning electron microscopy and EDAX. Alumina whiskers were noted on the surfaces of the NaCl exposed scale, a surface oxide characteristic similar to that seen on similarly tested NiAl specimens. EDAX analyses of metallographically prepared cross sections of specimens exposed at 900°C revealed the presence of a laminated oxide structure and enrichments of molybdenum near the metal-scale interface, Fig. 20. The surface of selected specimens were immersed in distilled water, and the only cation noted was molybdenum. Molybdenum trioxide is slightly soluble in water (Ref. 23).

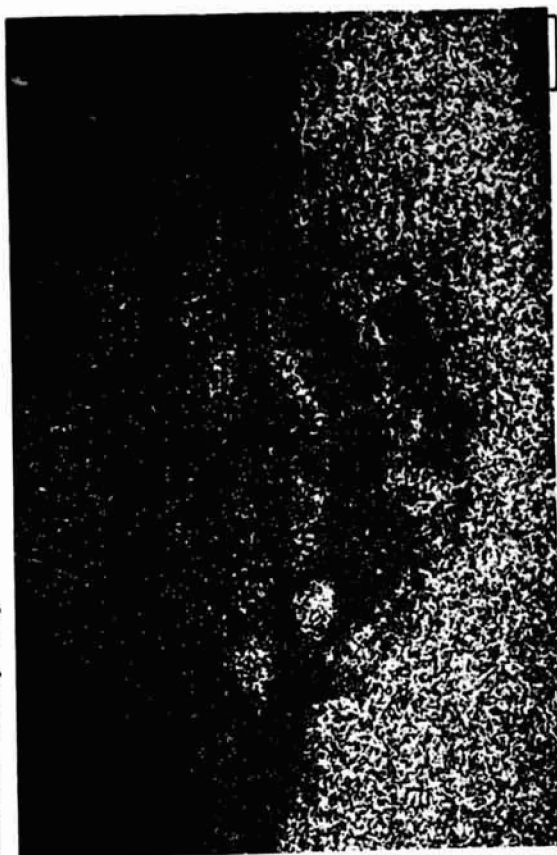
FIG. 22 B-1900 oxidized in air with 100 ppm NaCl(g) at 1050°C for 100 hours.

On the other hand, B-1900 specimens exposed for 100 hours at 1050°C to NaCl(g) at 100 ppm levels indicated only a few small oxide pits, Fig. 21. EDAX examination of these oxide pits, Fig. 22, revealed enrichments of chromium and aluminum but not molybdenum as was found in specimens tested at 900°C. Metallographic cross-sections of B-1900 specimens tested at 1050°C in air with 10 ppm levels of NaCl(g) were similar to those tested at 1050°C in air alone.

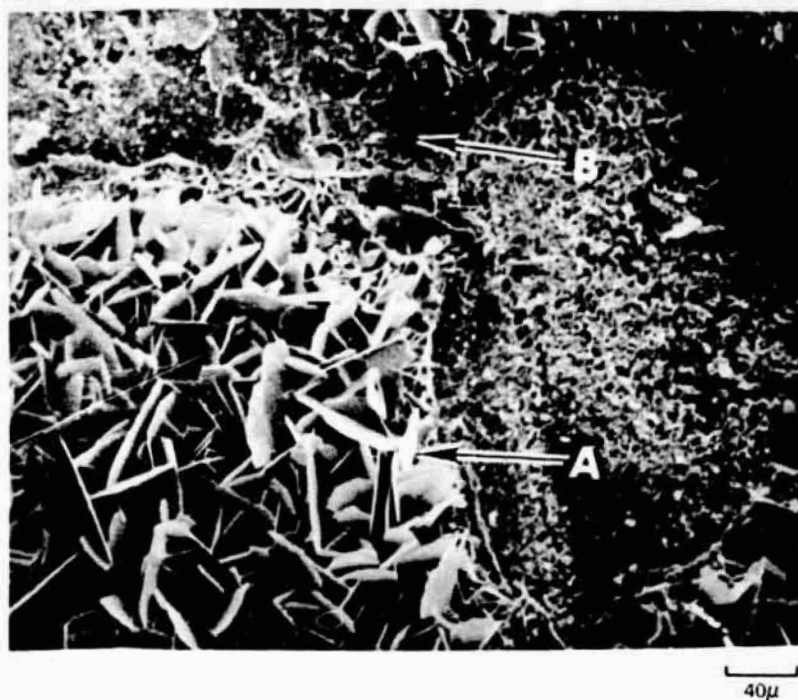
- a. A. Chromia crystals produced by molten salt effects  
 B. Matrix scale

- b. EDAX of matrix scale

FIG. 30 Chromia crystals (A) growing on a nickel-enriched oxide substrate (B).  $\text{Na}_2\text{SO}_4$  coated ( $1.0 \text{ mg/cm}^2$ ) Ni-25Cr oxidized in air at  $1050^\circ\text{C}$  for 100 hours.

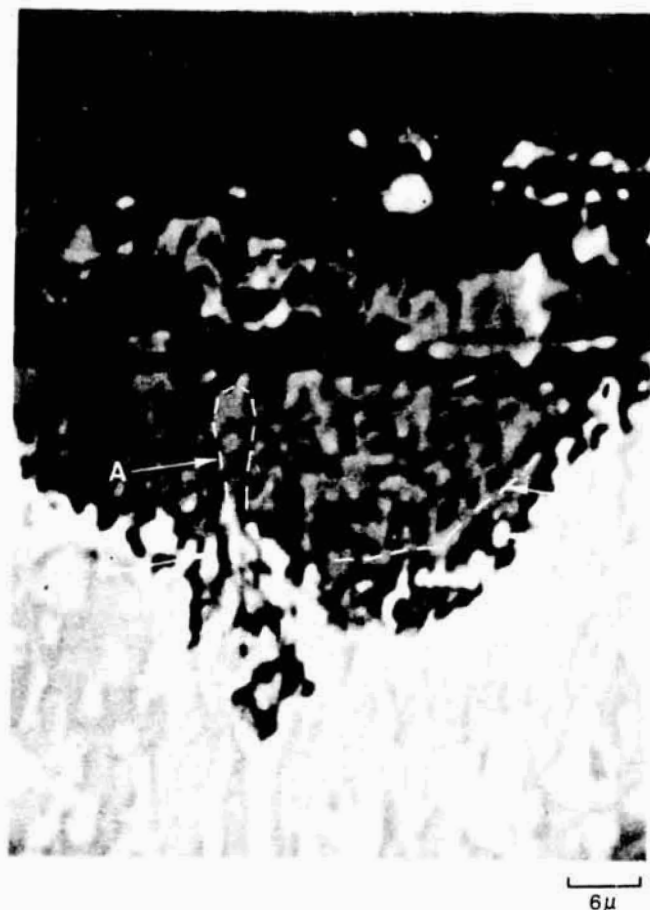
FIG. 40 Pitting attack of CoCrAlY after 58 cycles showing the presence of a retained substrate morphology in the oxide pit coincident with the prior  $\alpha$ -Co grains in the CoCrAlY coating (A), prior corrosion front images (B) and  $\beta$ -cobalt islands in the oxide pit (C). (Scanning electron micrograph)

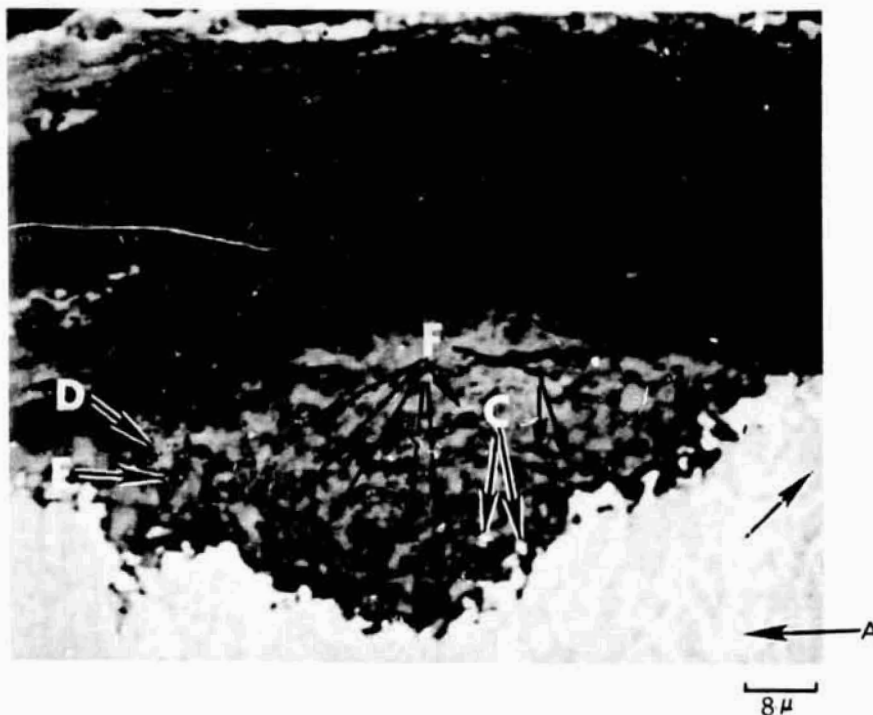
FIG. 41 Pitting Attack of CoCrAlY

\*(1 cycle: Exposure at 1300°C in a preheated furnace for 30 seconds with intervening time spent in furnace at 700°C, sodium sulfate (~1 mg/cm<sup>2</sup>) deposits reapplied every 15 cycles, fuel applied each cycle.)

A. Cobalt X-ray Map

B. Chromium X-ray Map

C. Aluminum X-ray Map

D. Sulfur X-Ray Map

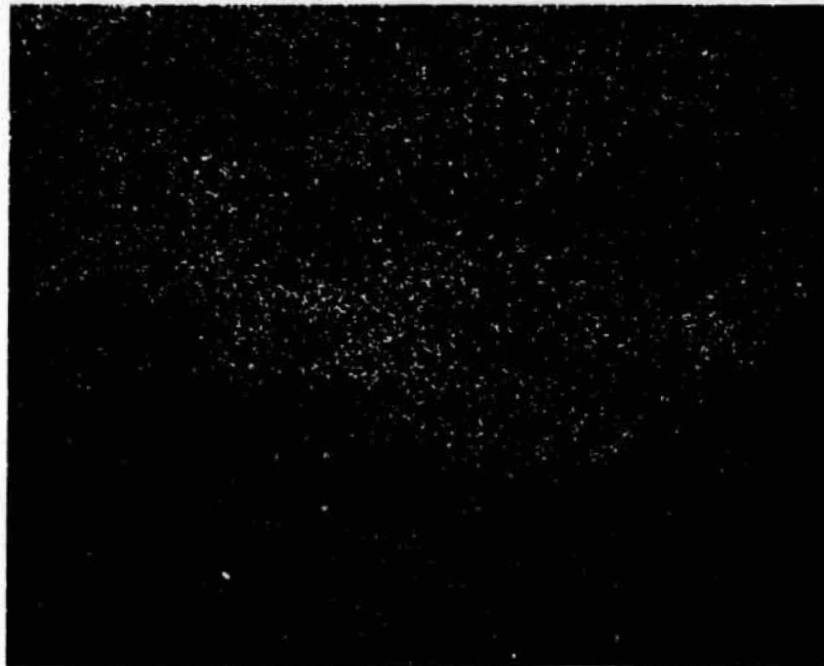
FIG. 42 Metallographic studies of the base of the oxide pit, cf. FIG. 41.

A. Cobalt X-ray Map

B. Chromium X-ray Map

C. Aluminum X-Ray Map

D. Sulfur X-ray Map
